# **Navajo Abandoned Uranium Mine**

## **Site Screen Report**

### **Juan Horse No. 3 AUM Site**

#### **Navajo AUM Western Region**

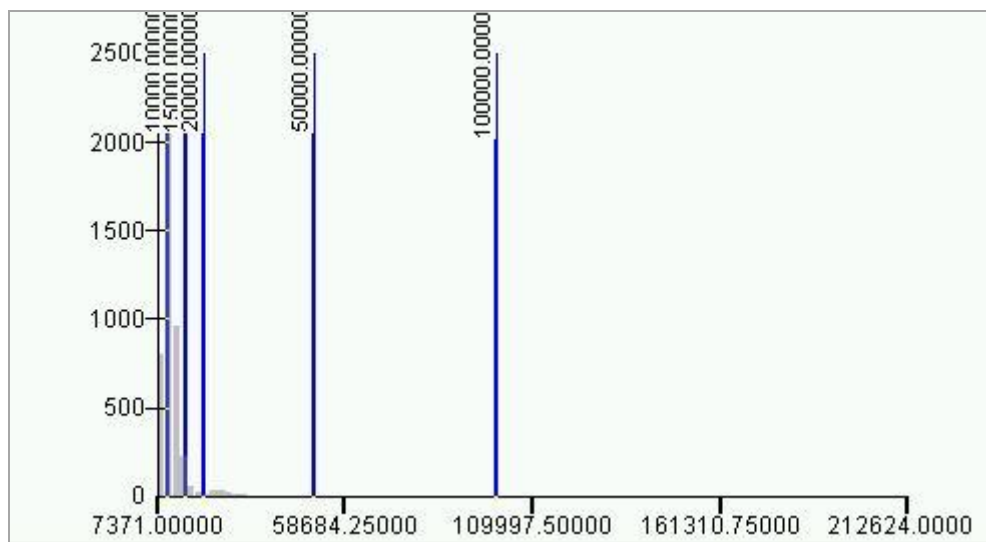
The following chart and statistics were generated by ESRI ArcGIS 9.3.1, and show the general distribution of the site gamma radiation measurements. The horizontal X axis represents the gamma radiation reading levels in cpm (lowest levels to the left). The vertical Y axis represents the frequency of each gamma radiation level.

Count:	4696
Minimum:	7371.00000
Maximum:	212624.00000
Sum:	58112939.00000
Mean:	12374.98701
Median:	10635.00000
Standard Deviation:	12271.65629

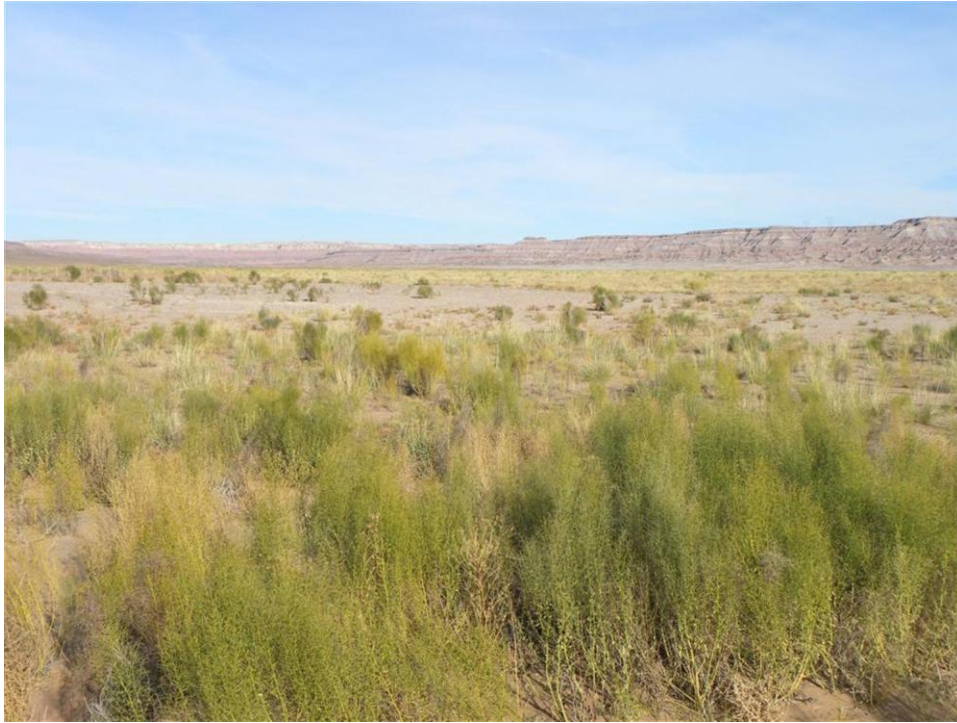
Photo 1. Juan Horse No. 3 mine site

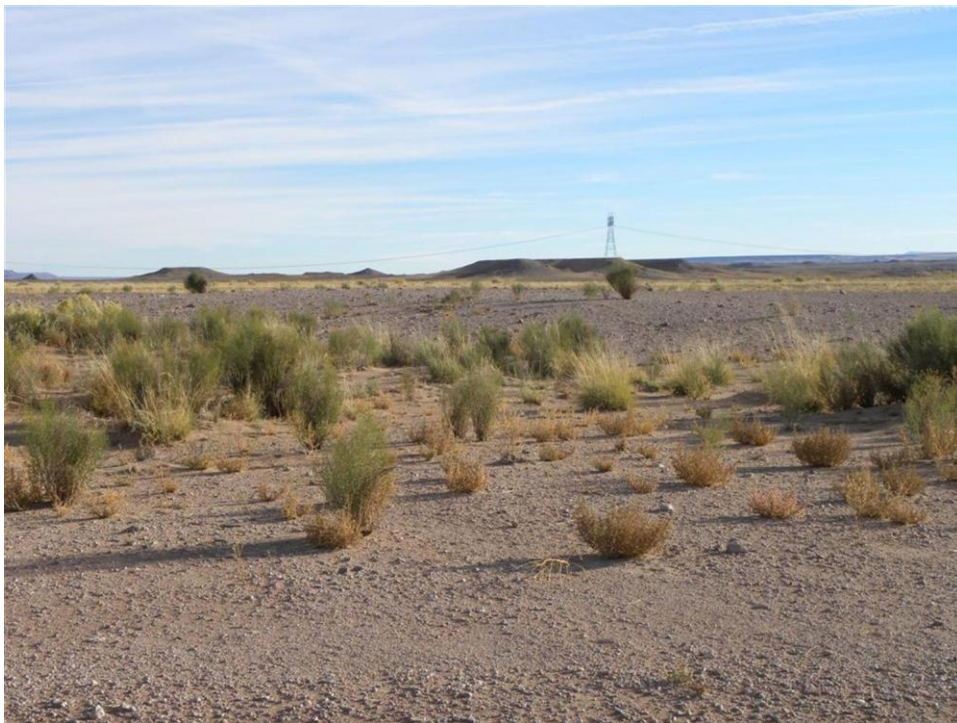
Reclamation cap in the center of the site, approximately 200' x 100'

Photo 2. Juan Horse No. 3 mine site, reclamation cap

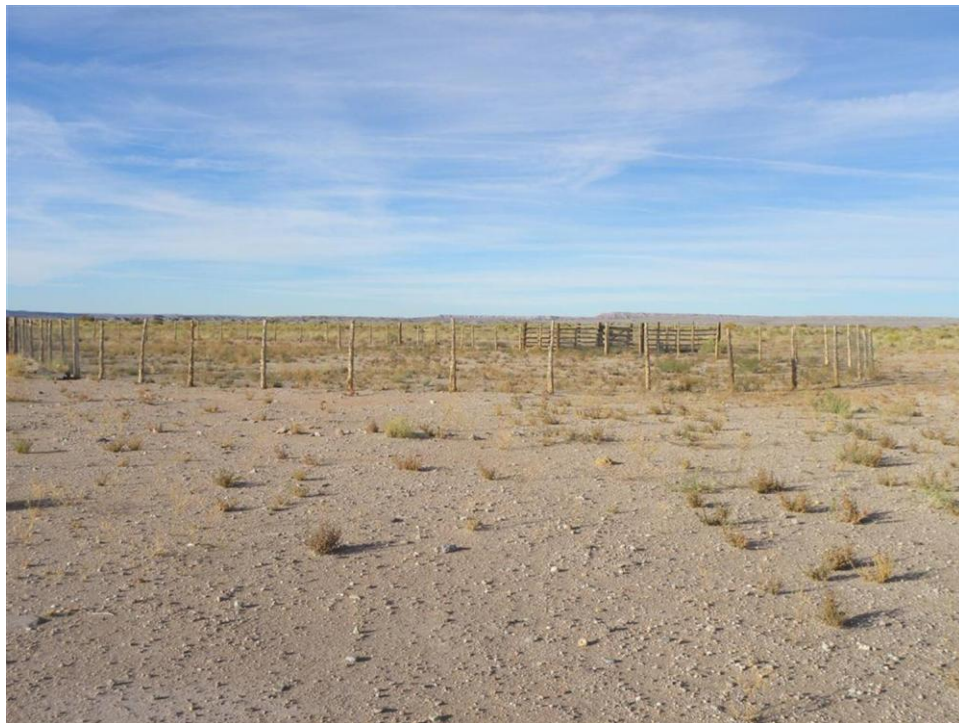
Photo 3. Juan Horse No. 3 mine site, livestock pen

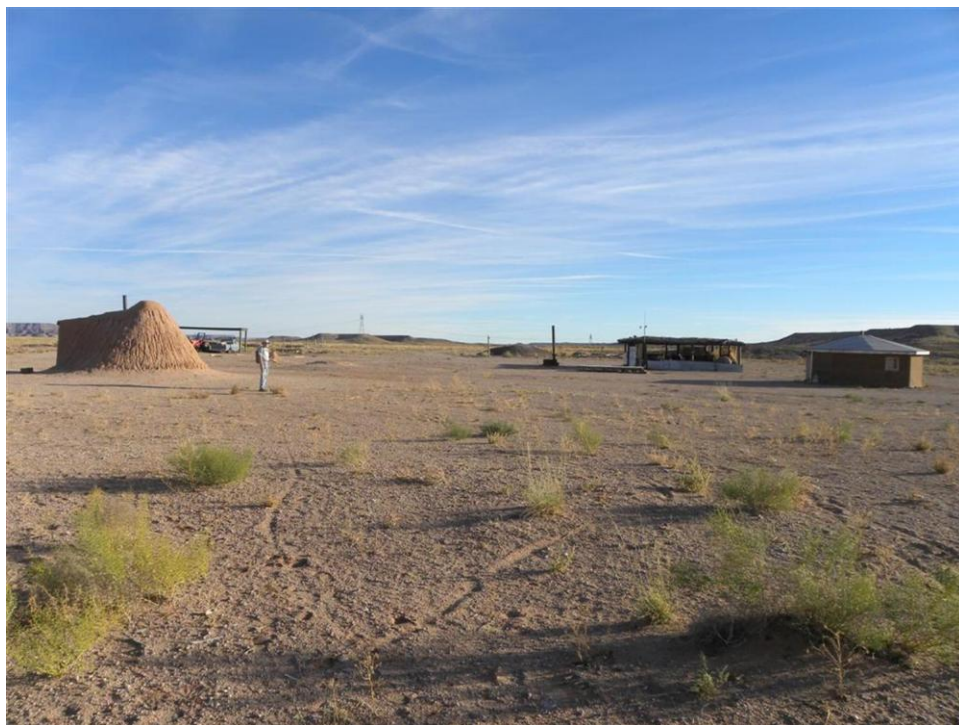
**200 feet to 0.25 mile:** 5 structures approximately 0.15 mi W of site (1 hogan, 1 small mud structure, 1 garage cover, 1 cooking area, 1 outhouse)

Photo 4. Juan Horse No. 3 mine site, nearby structures

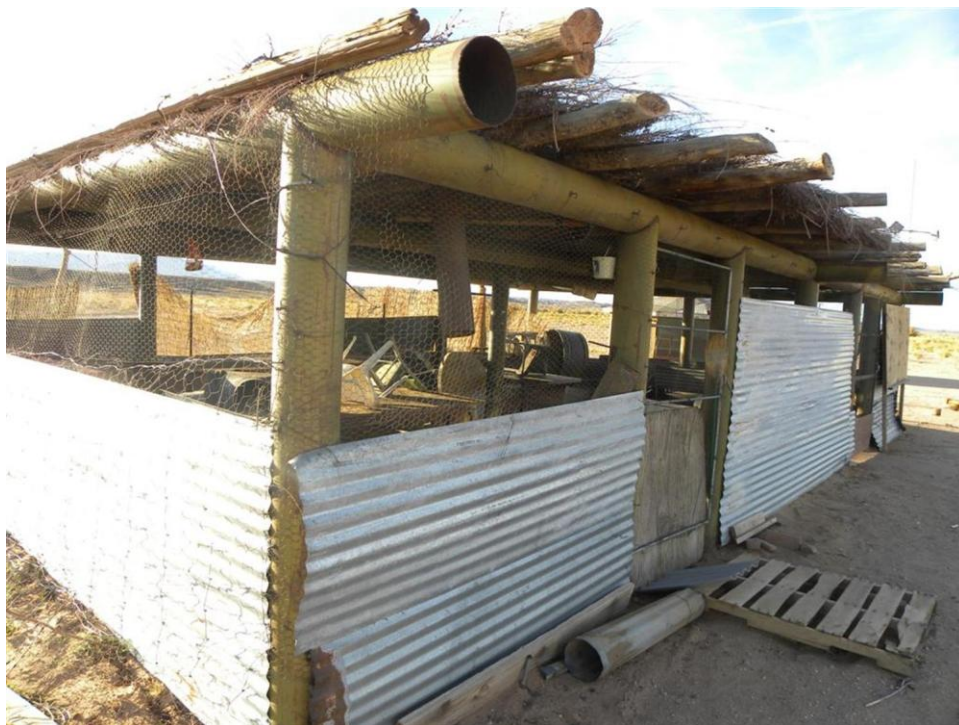
Photo 5. Juan Horse No. 3 mine site, nearby structures

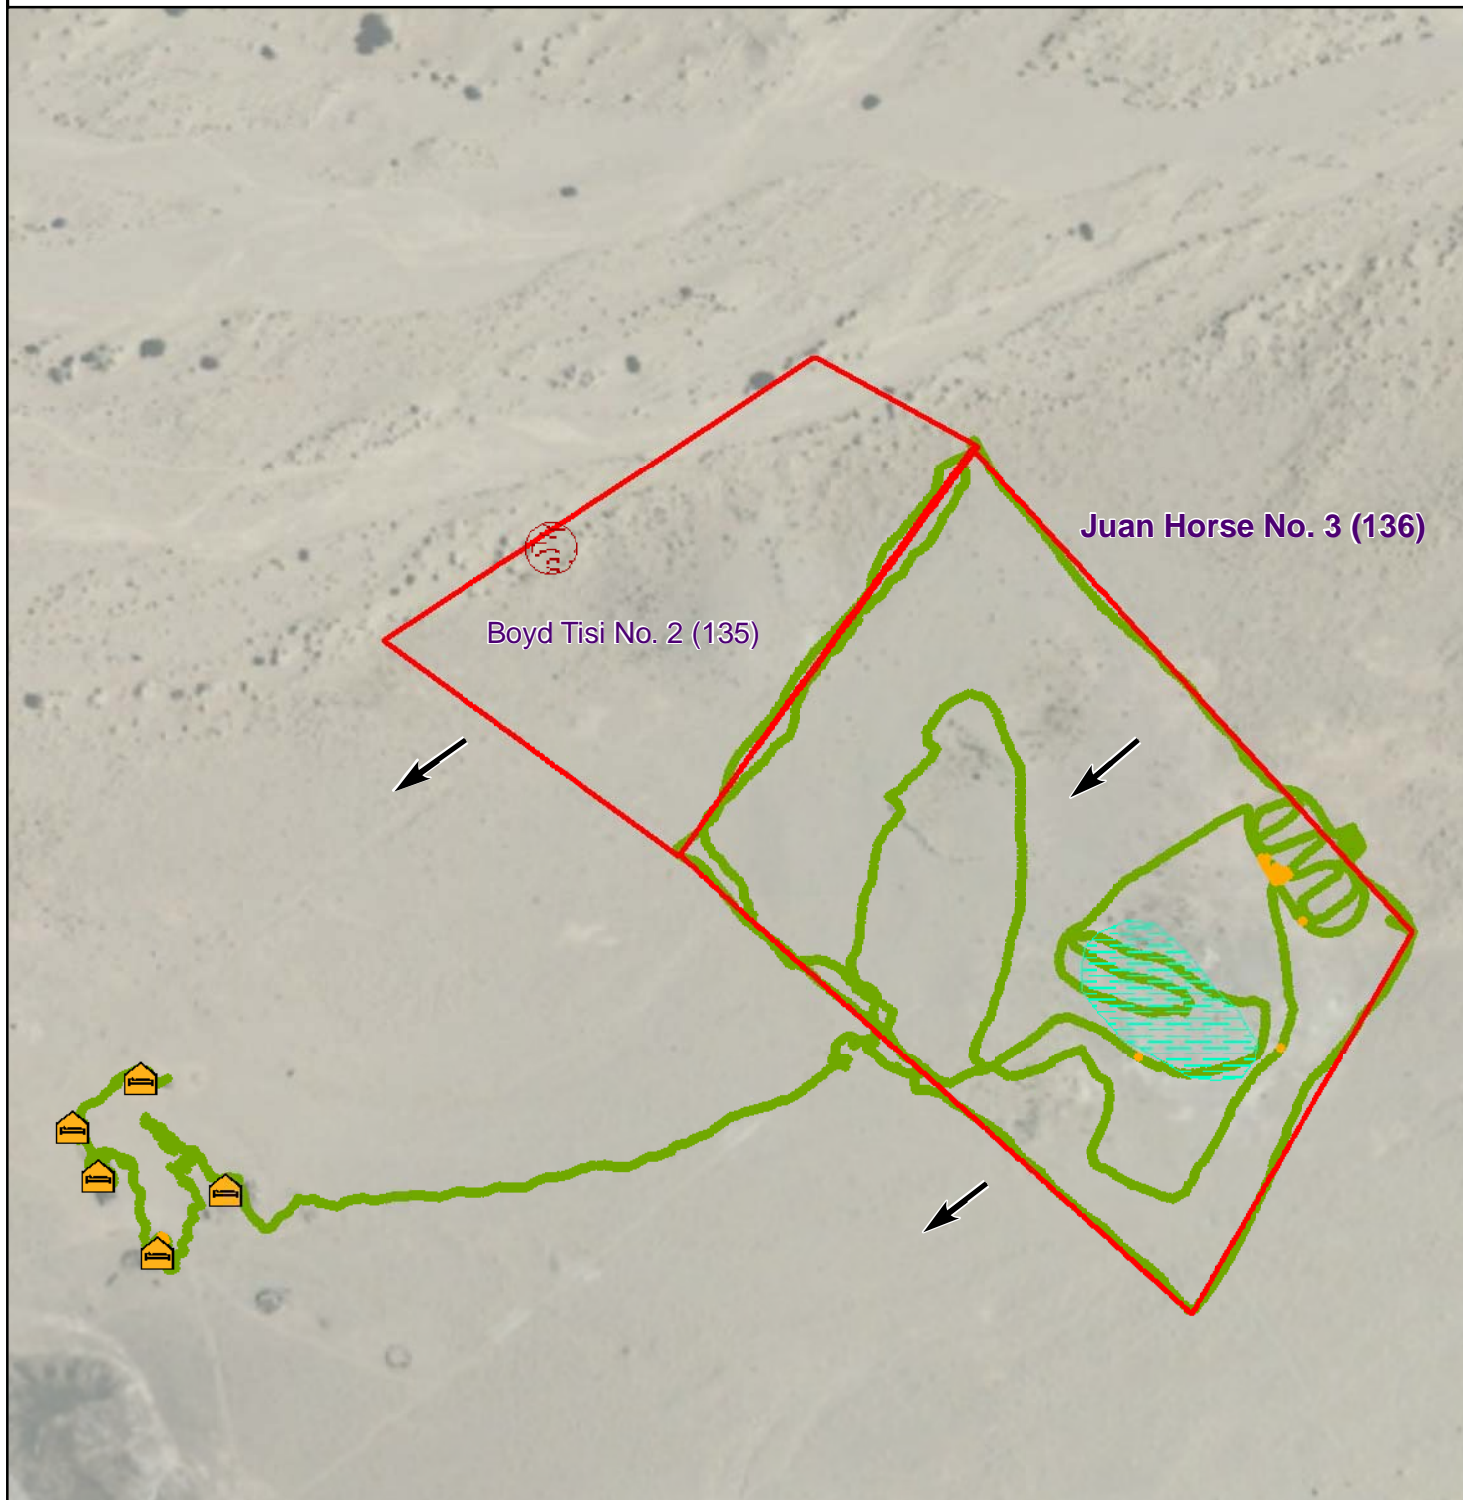
**Figure 1 - Gamma Radiation Measurements, Above Two Times Background  
Juan Horse No. 3 (136)  
Coalmine Mesa Chapter, Navajo Nation**

A total of 4,696 gamma radiation measurements were collected from the mine site, ranging from 7,371 cpm to 212,624 cpm. A petrified log near the structures 0.15 mi west of the site was found at over 200,000 cpm. The measurements are represented in Figures 1 and 2.

Gamma survey conducted 11/2010  
Measured as counts per minute (cpm)

Average background 11,523 cpm

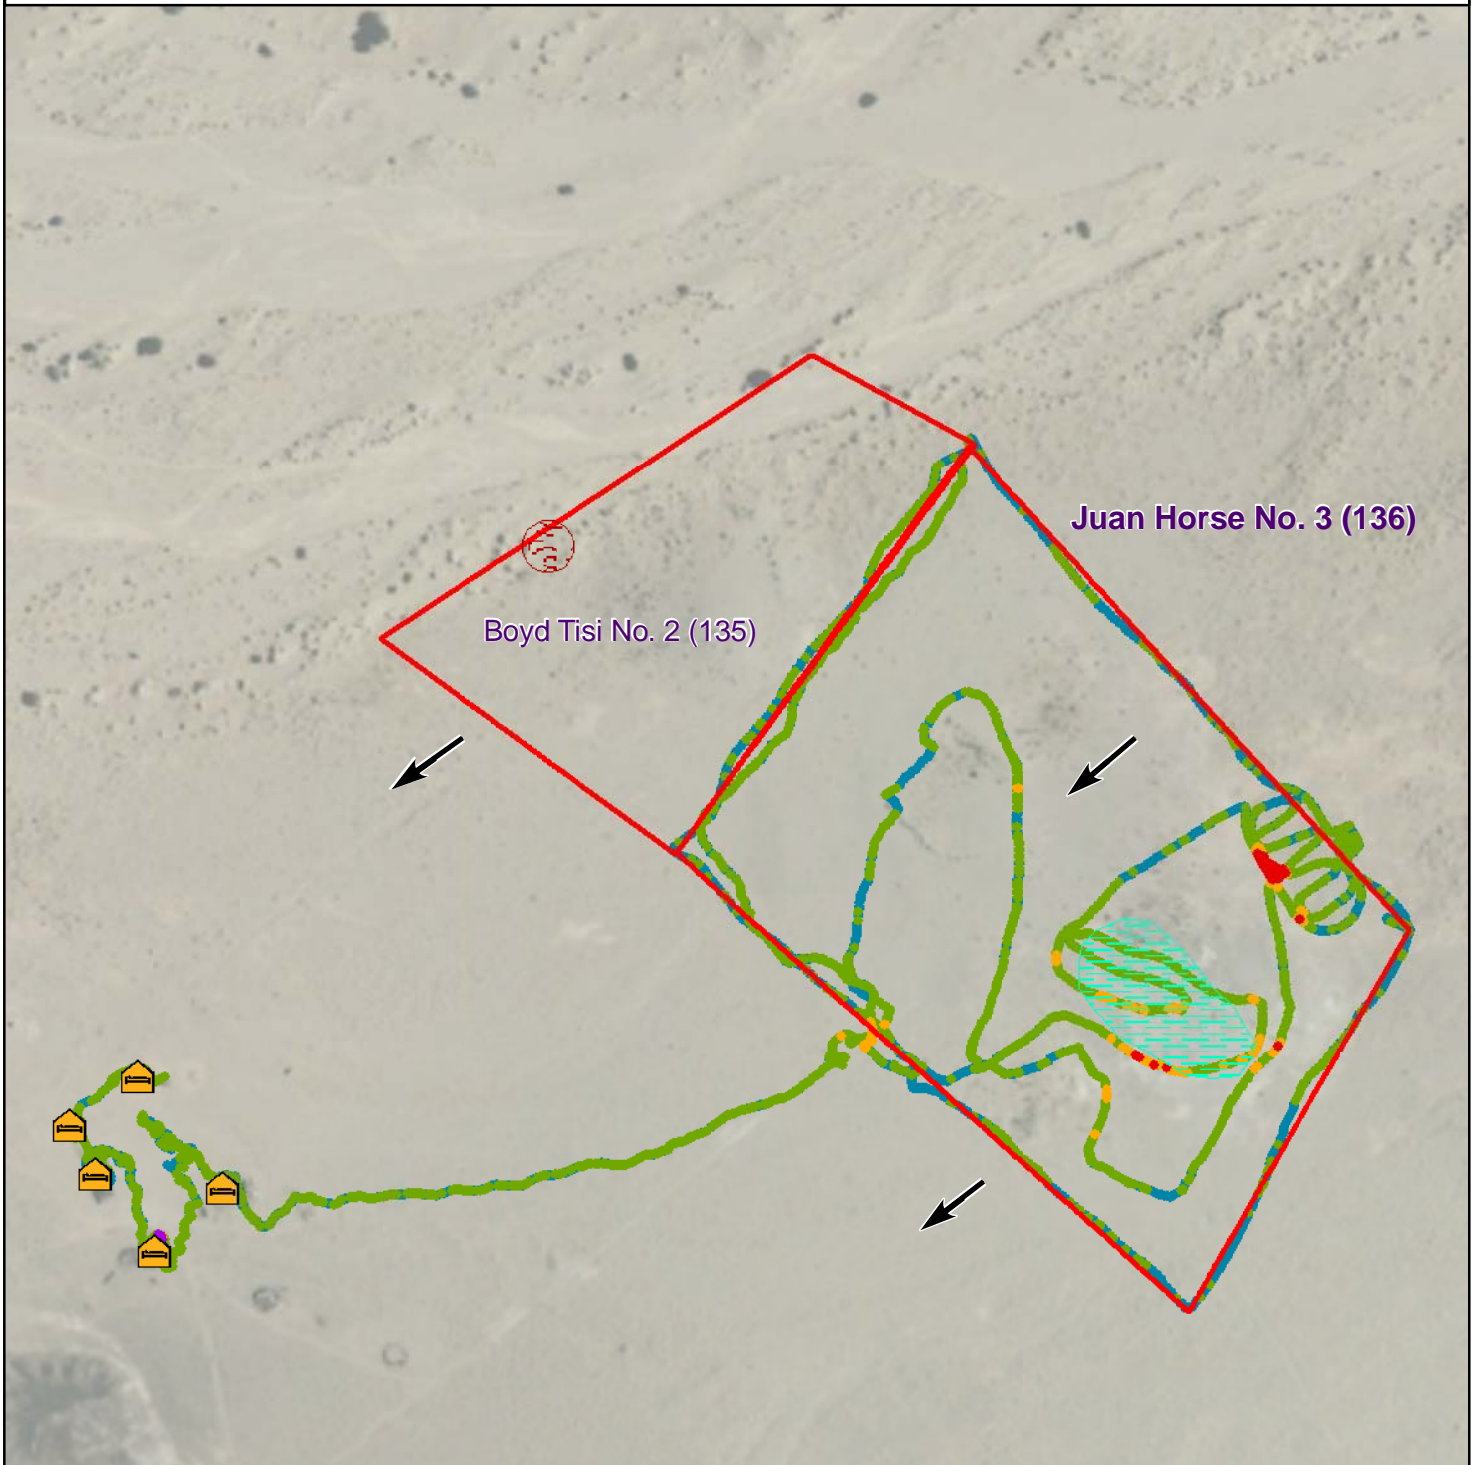
**Figure 2 - Gamma Radiation Measurements**  
**Juan Horse No. 3 (136)**  
**Coalmine Mesa Chapter, Navajo Nation**

Average background 11,523 cpm

Gamma survey conducted 11/2010  
 Measured as counts per minute (cpm)
